**Town of Grafton, Massachusetts Fire Department**  
**Fire Apparatus Fleet Review and Assessment**

# **TOWN OF GRAFTON FIRE DEPARTMENT APPARATUS FLEET REVIEW**

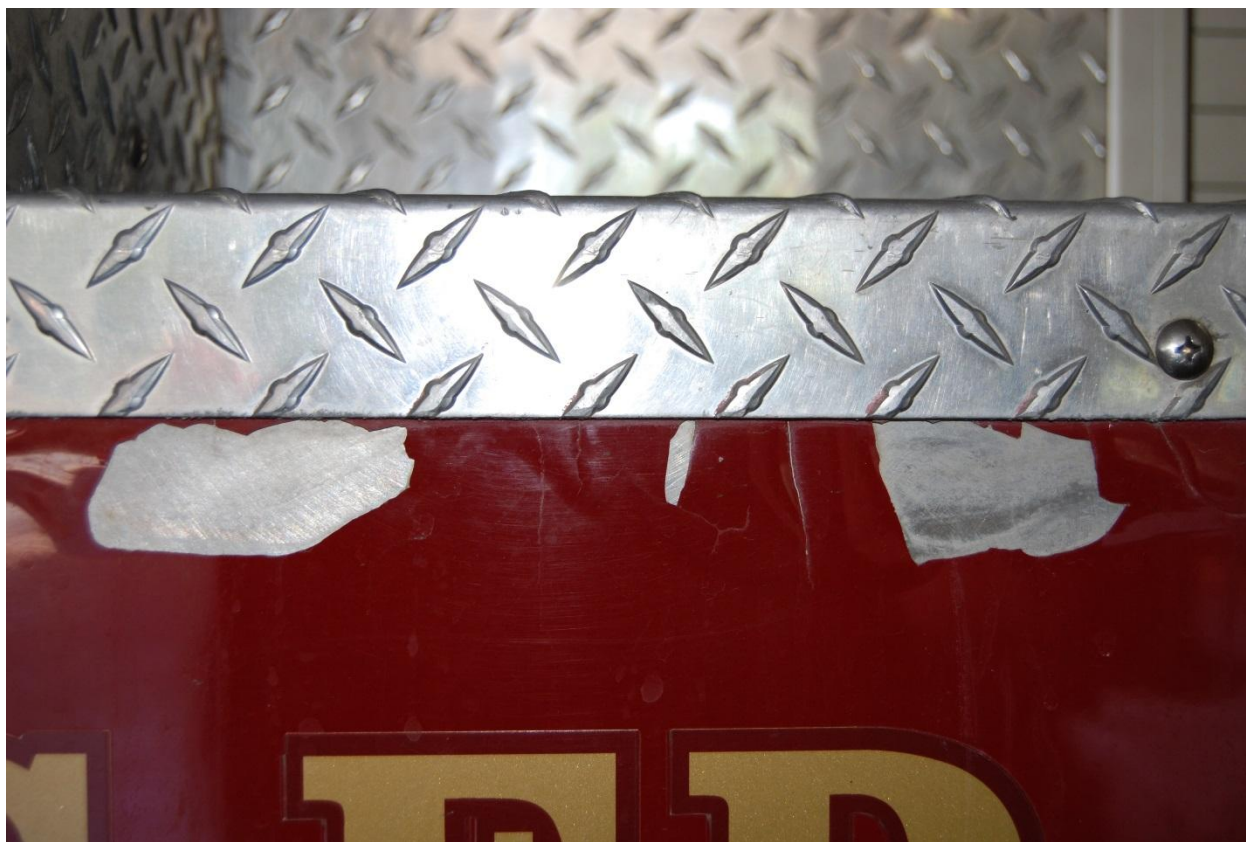
**Image 5.3 Rear body paint on Engine 1**

- 9. Repairs should be initiated on a timely basis to repair the paint damaged areas on the rear body and around the door hardware on the compartment doors.*

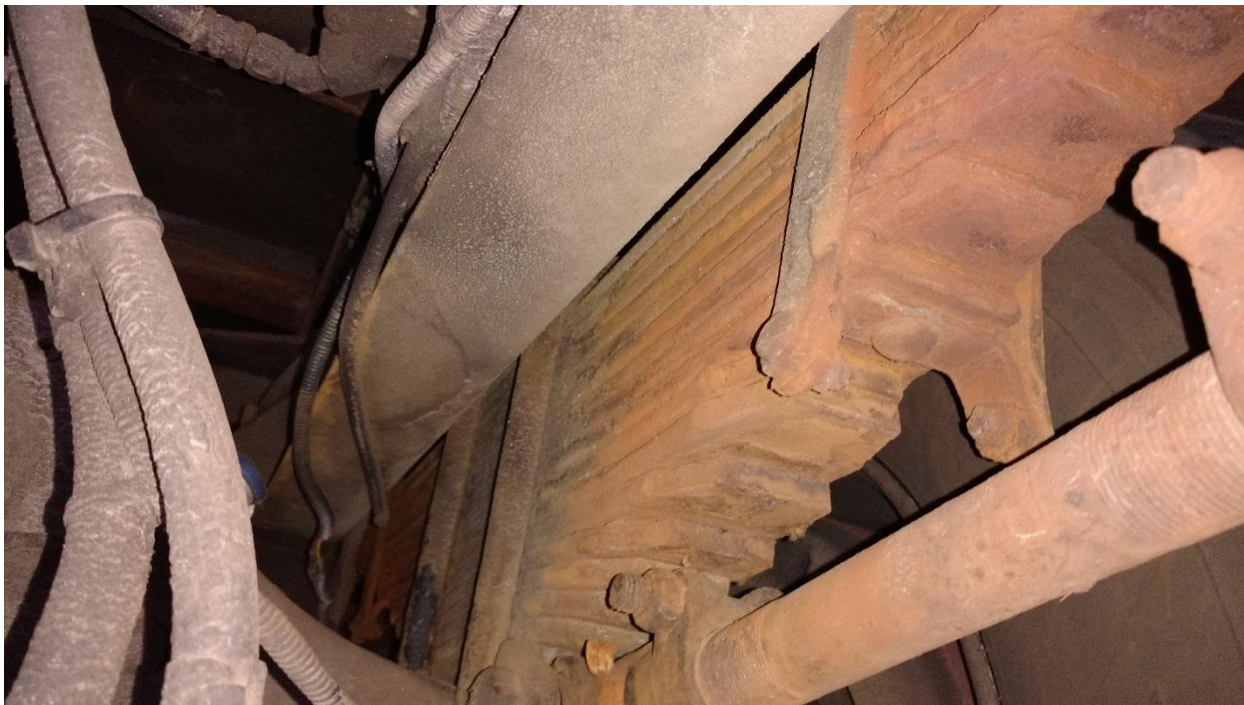
**Image 5.4 Rear spring suspension on Engine 1**

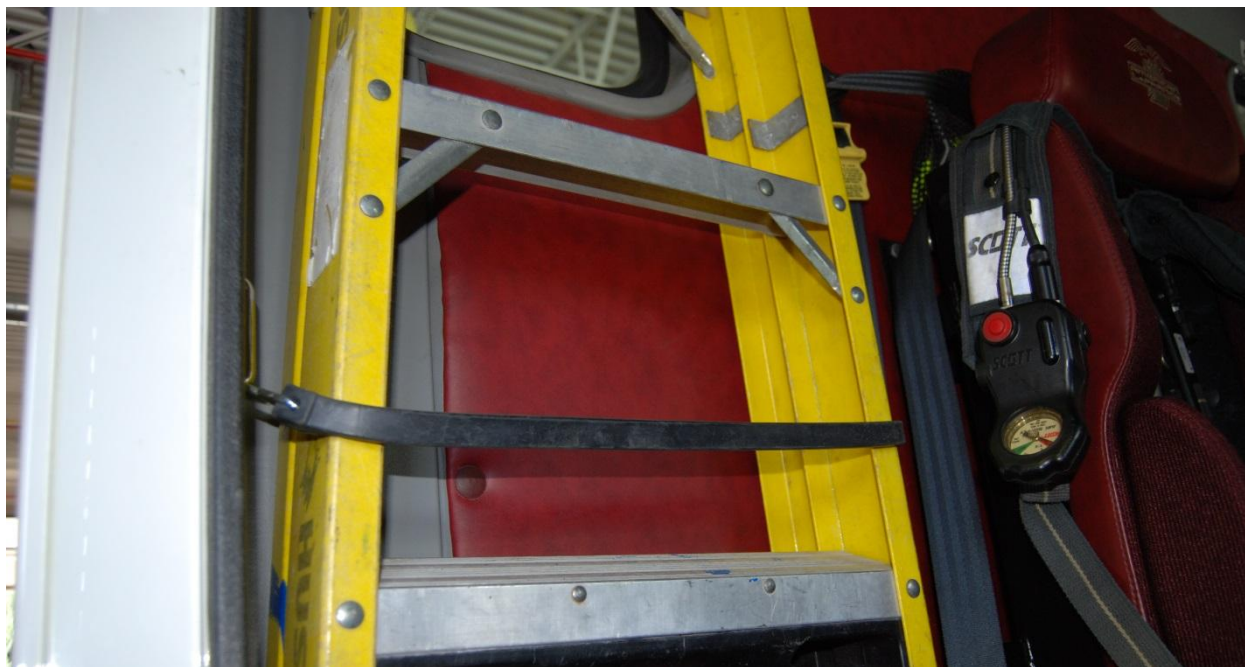
**Image 5.5 Step ladder carried inside of Engine 1 crew area**

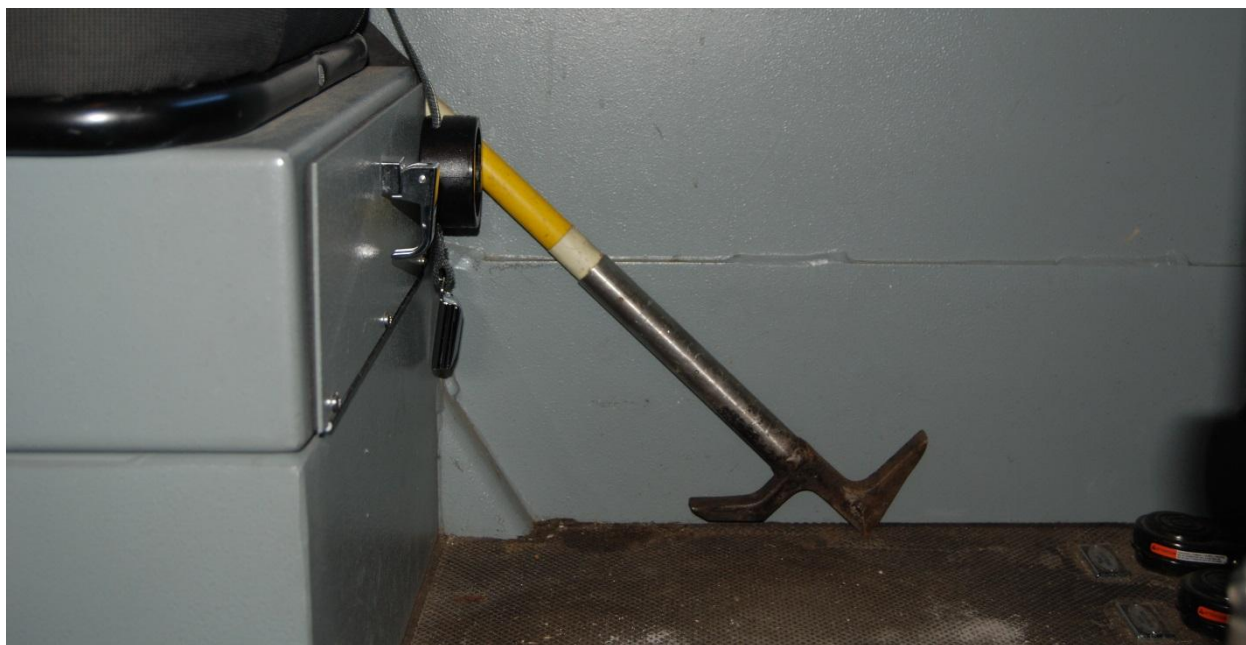
**Image 5.7 Unsecured hand tool adjacent to officers seat on Engine 2**

*10. To the extent possible, spare nozzles, fittings, hand tools and equipment locations should be standardized on the three front line engines operated by the department. As Engine 2 is the newest engine apparatus in the fleet, the use of tool boards similar to Pac Trac, pegboard or other similar material should be utilized to mount and secure all equipment carried on the apparatus.*

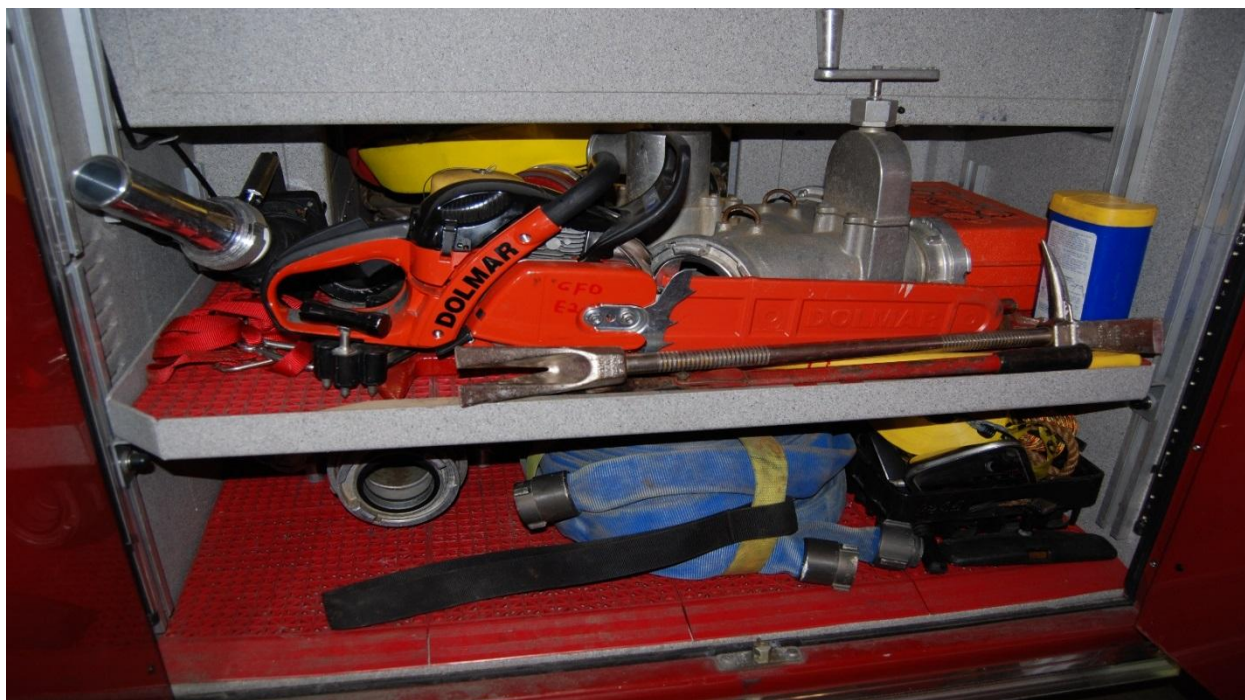
**Image 5.8 Unsecured equipment on Engine 2**

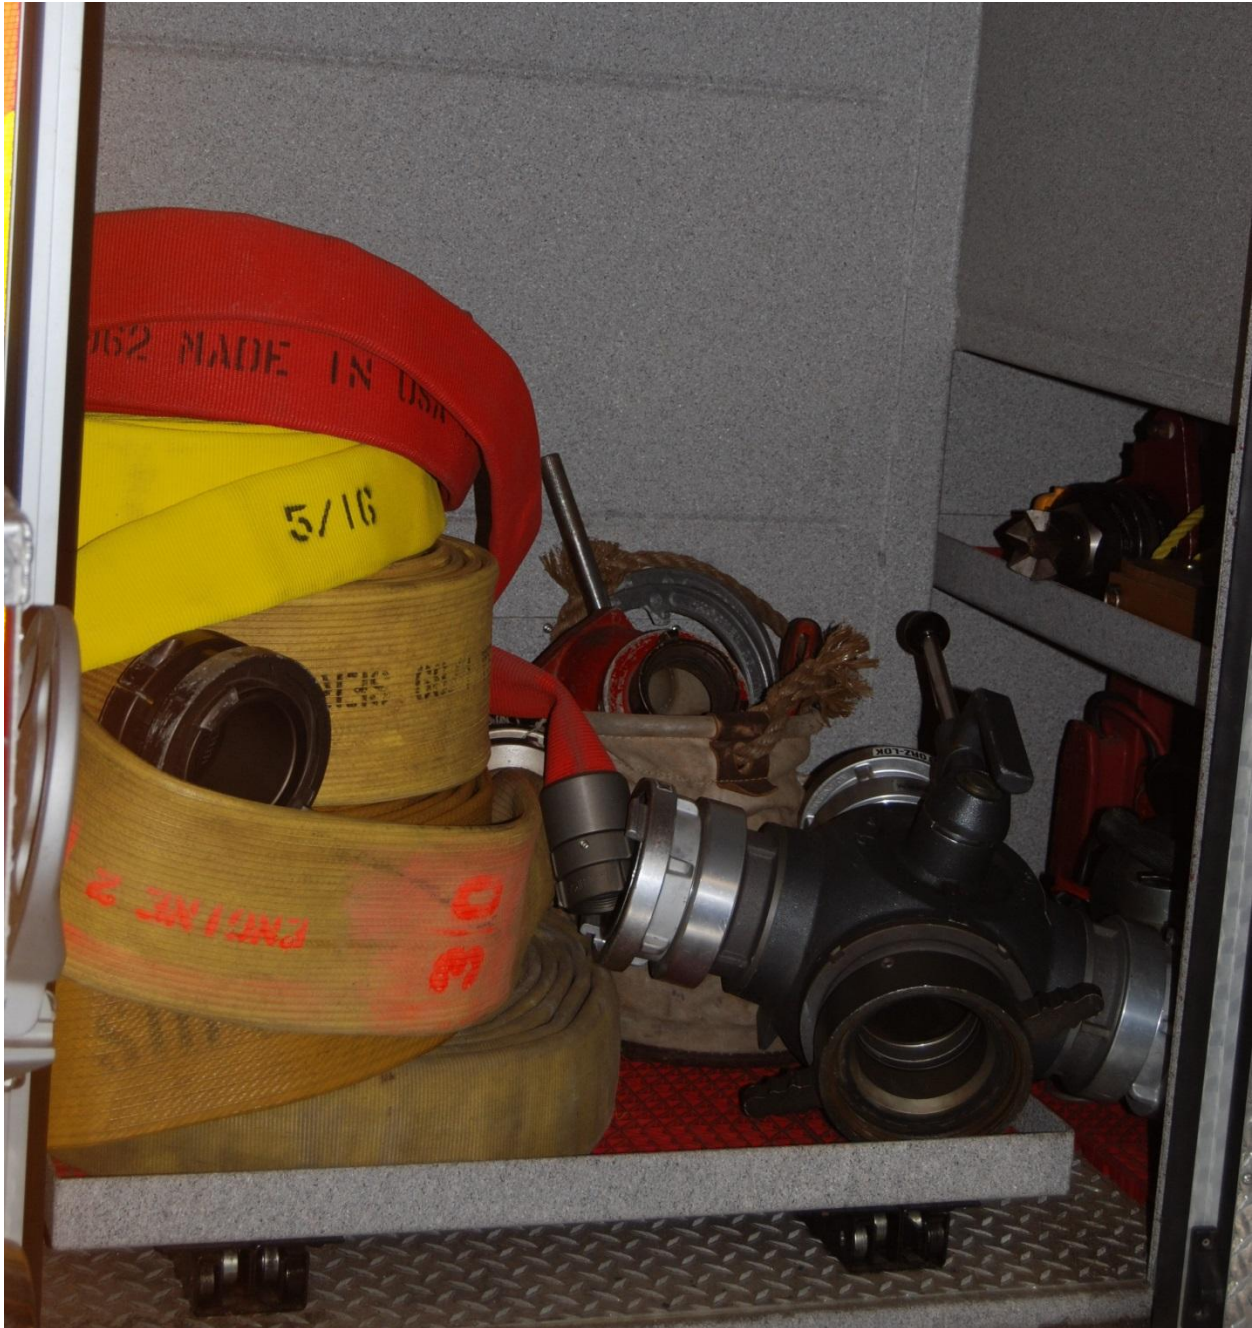
**Image 5.9 Engine 2 rear body compartment with spare 2.00 inch and 4.00 inch hose  
Four way hydrant valve and hydrant bag carried loose on slide tray**

*9. The four inch supply line bed should be connected to the four way hydrant valve along with a layout pack consisting of a hydrant wrench, spanner and 2.50 inch hydrant gate.*

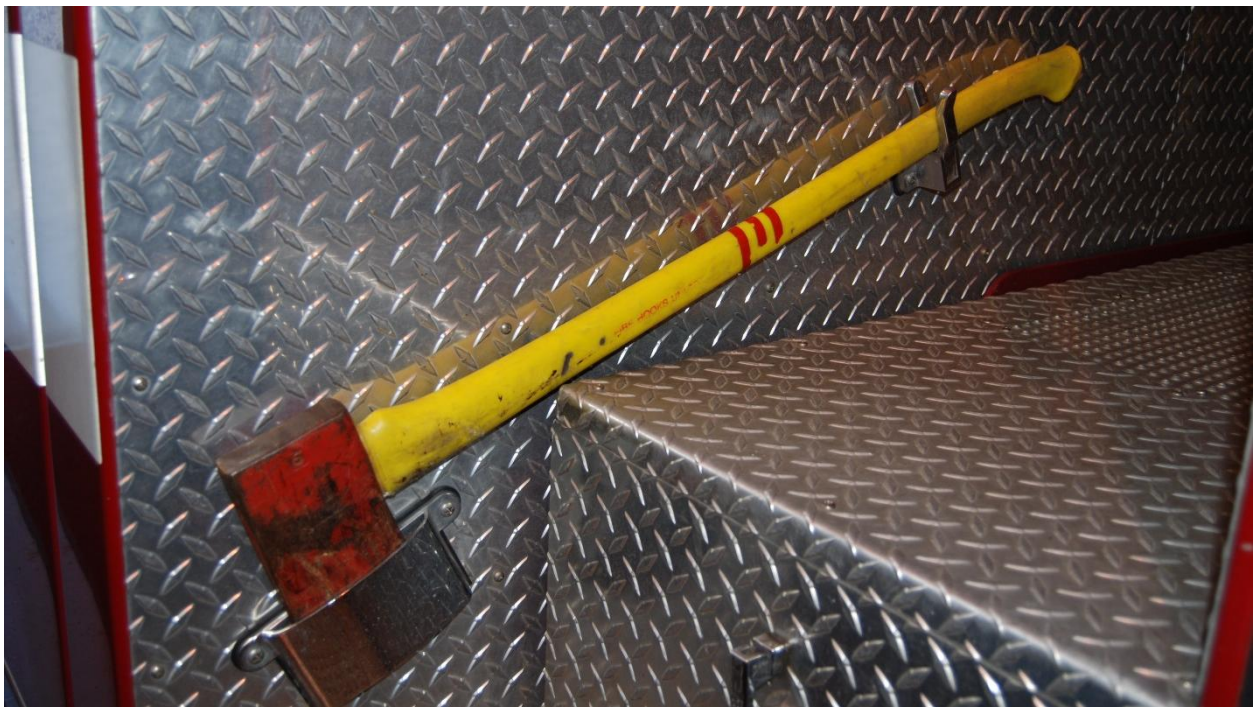
**Image 5.12 Rear cab axe mounting on Engine 3**

- 9. The axes mounted on the rear exterior of the cab should be mounted in NFPA 1901 compliant 9G rated and certified brackets with stainless steel hardware.*

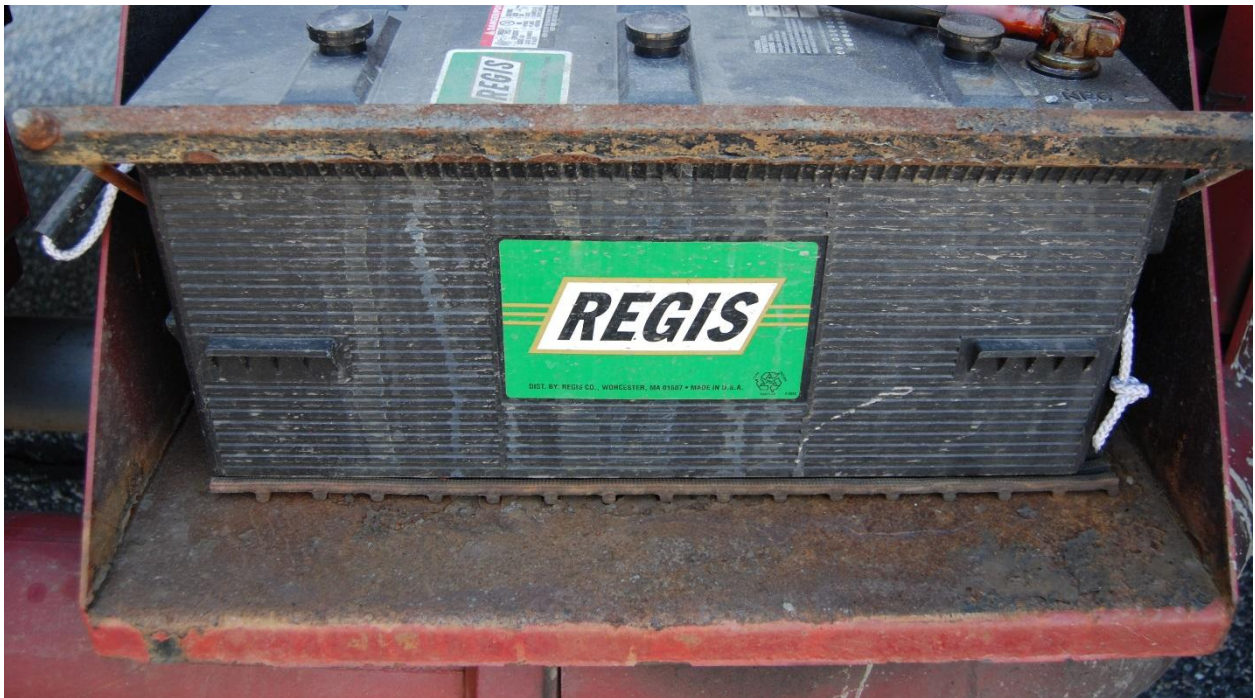
**Image 5.13 Battery tray corrosion on Engine 3**

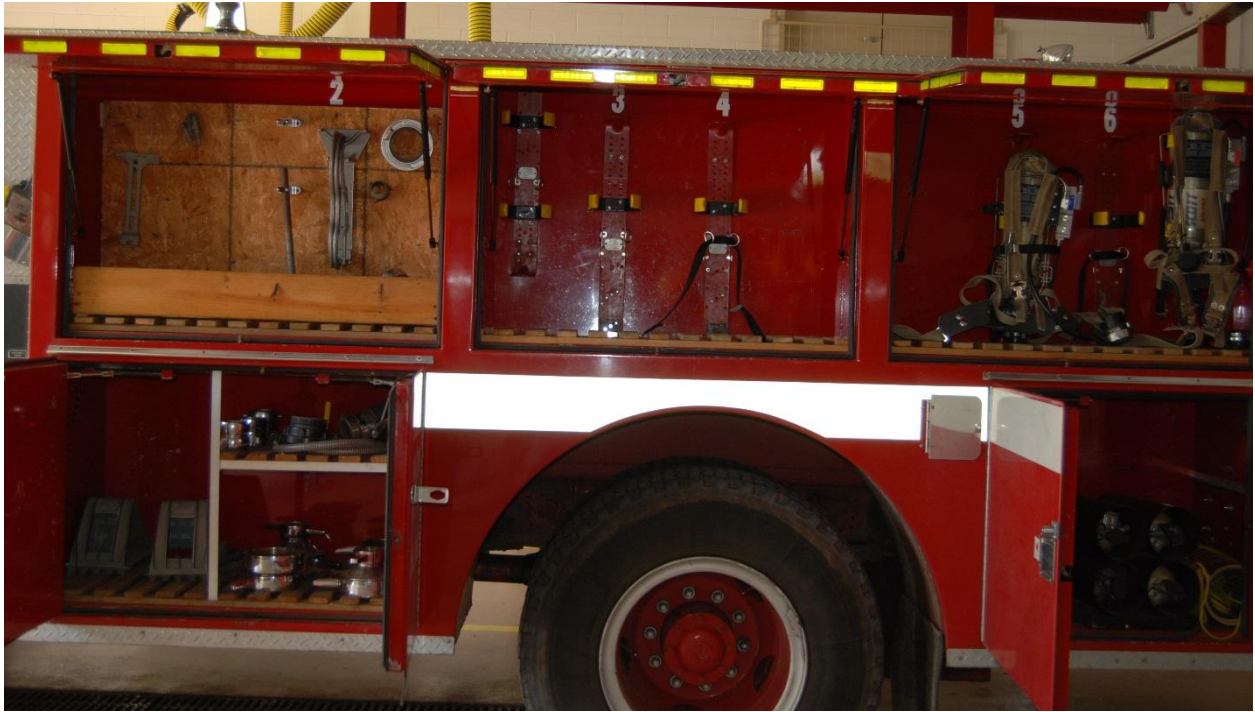
**Image 5.15 Engine 4 Equipment compartments**

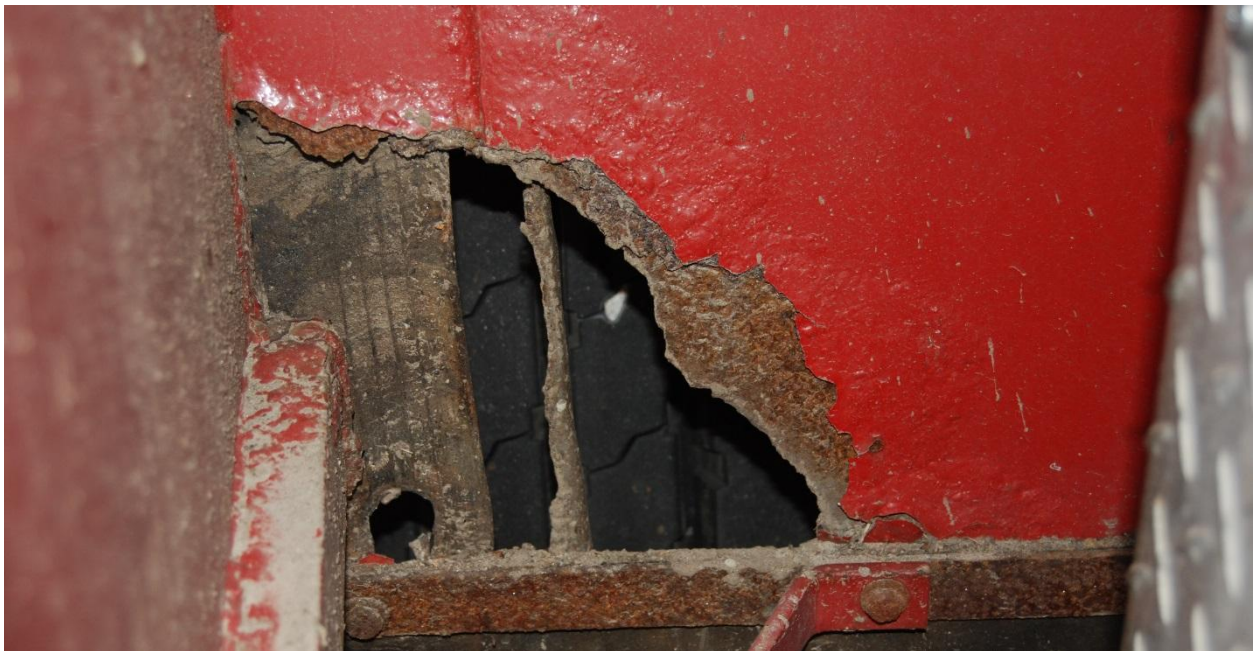
**Image 5.16 Engine 4 inner front cab fender corrosion**

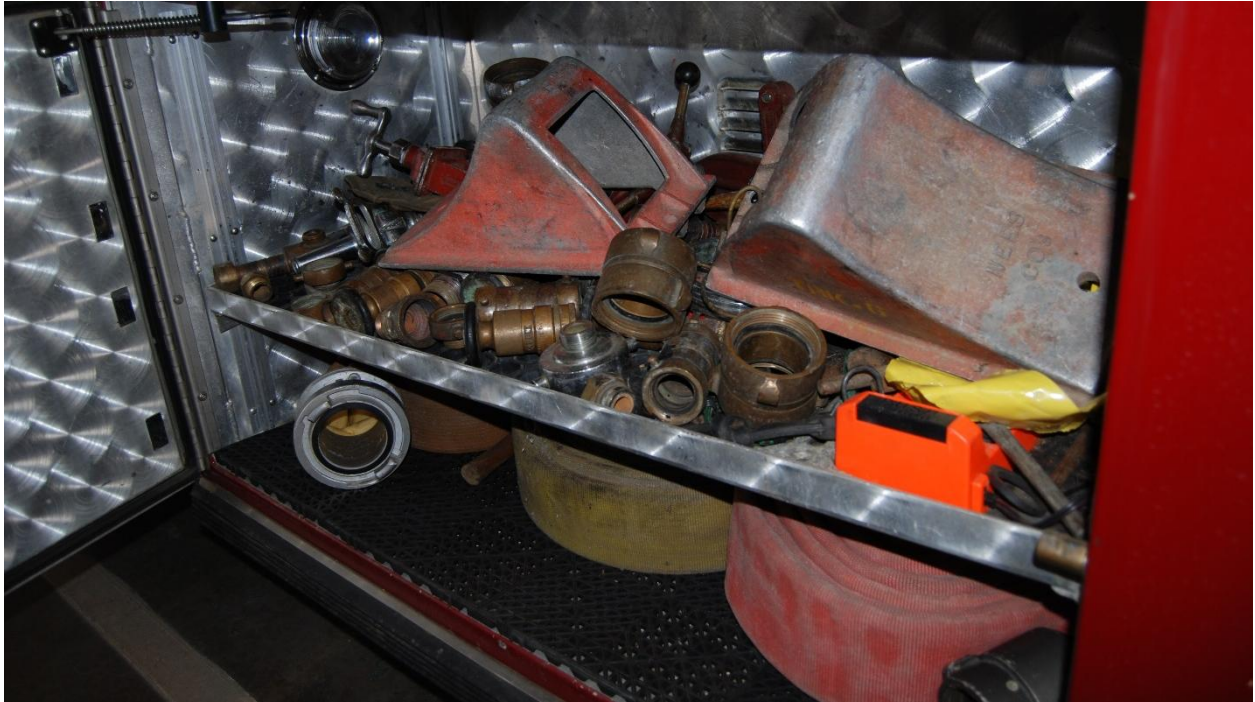
**Image 5.18 Engine 10 Left front compartment equipment storage**

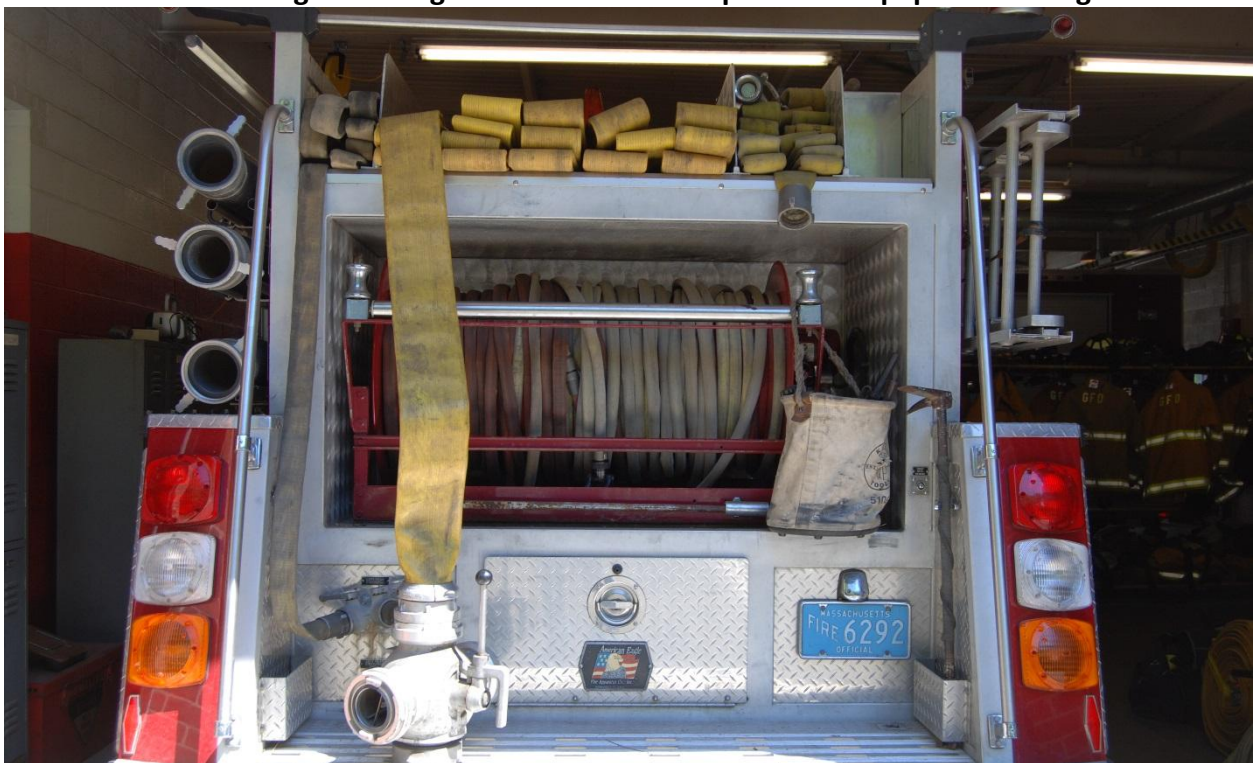
**Image 5.19 Engine 10 Rear body and hose bed**

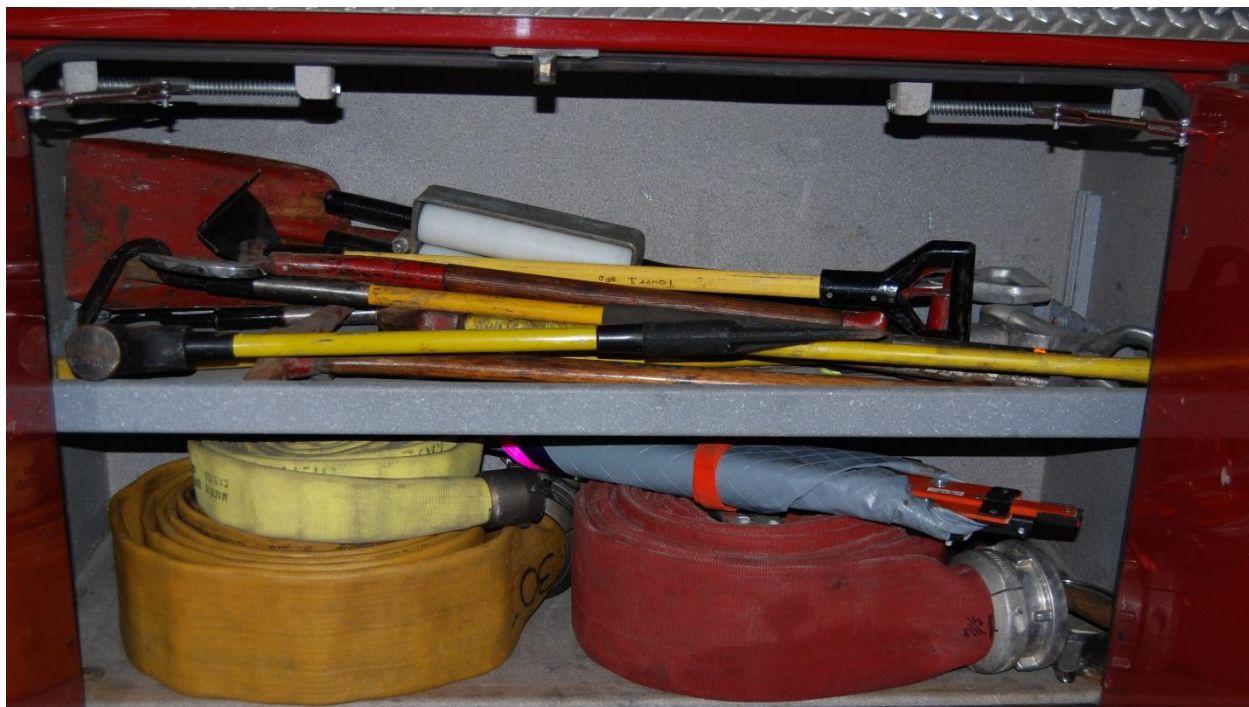
**Image 5.25 Compartment equipment storage on Tower 1**

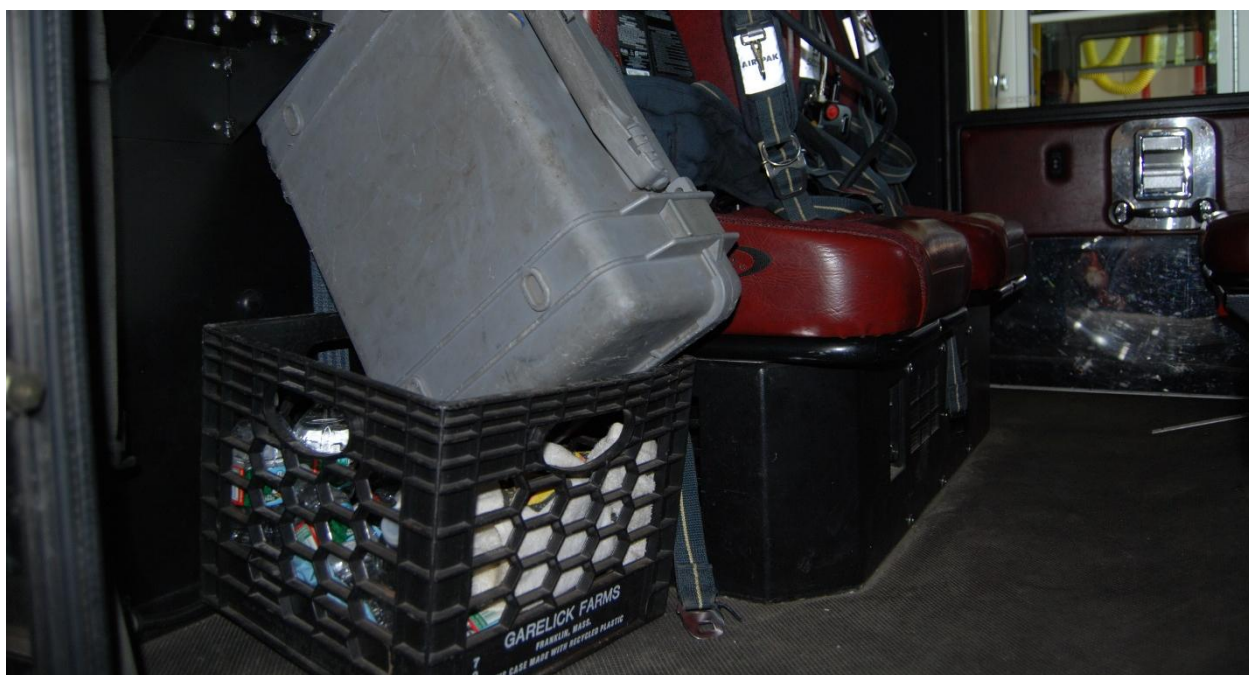
**Image 5.26 Loose equipment inside crew cab on Tower 1**

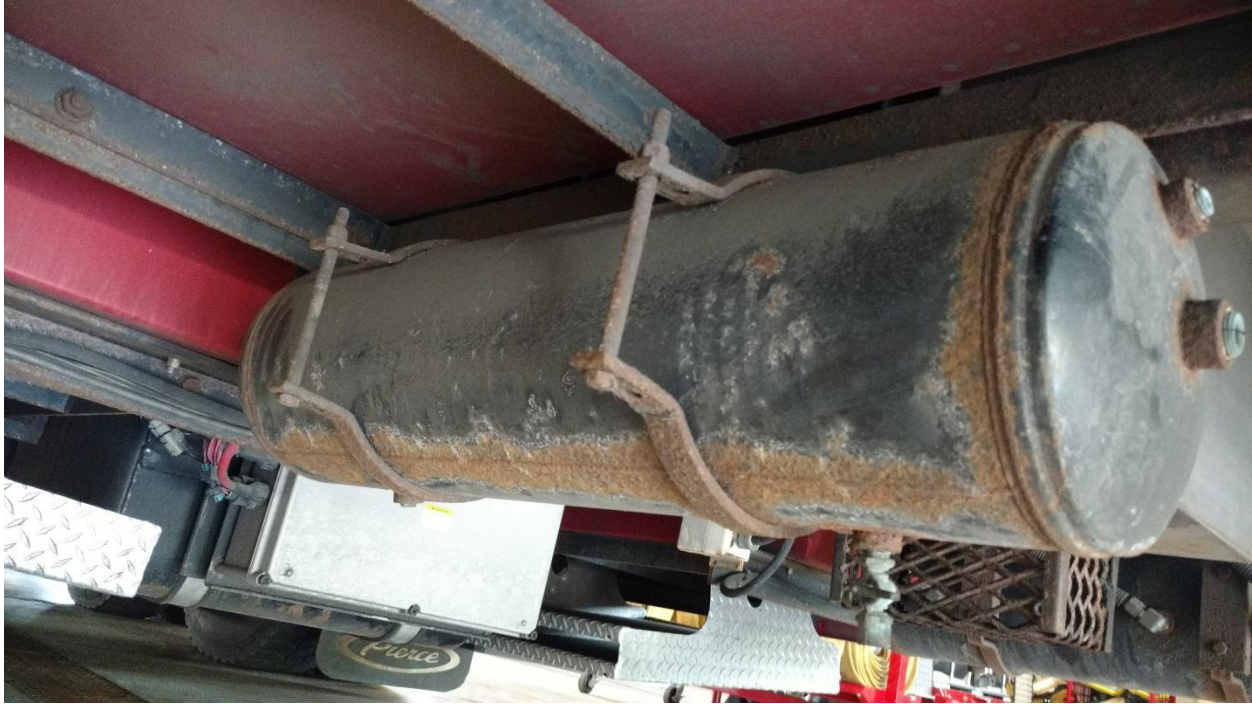
**Image 5.27 Air reservoir corrosion on Tower 1**

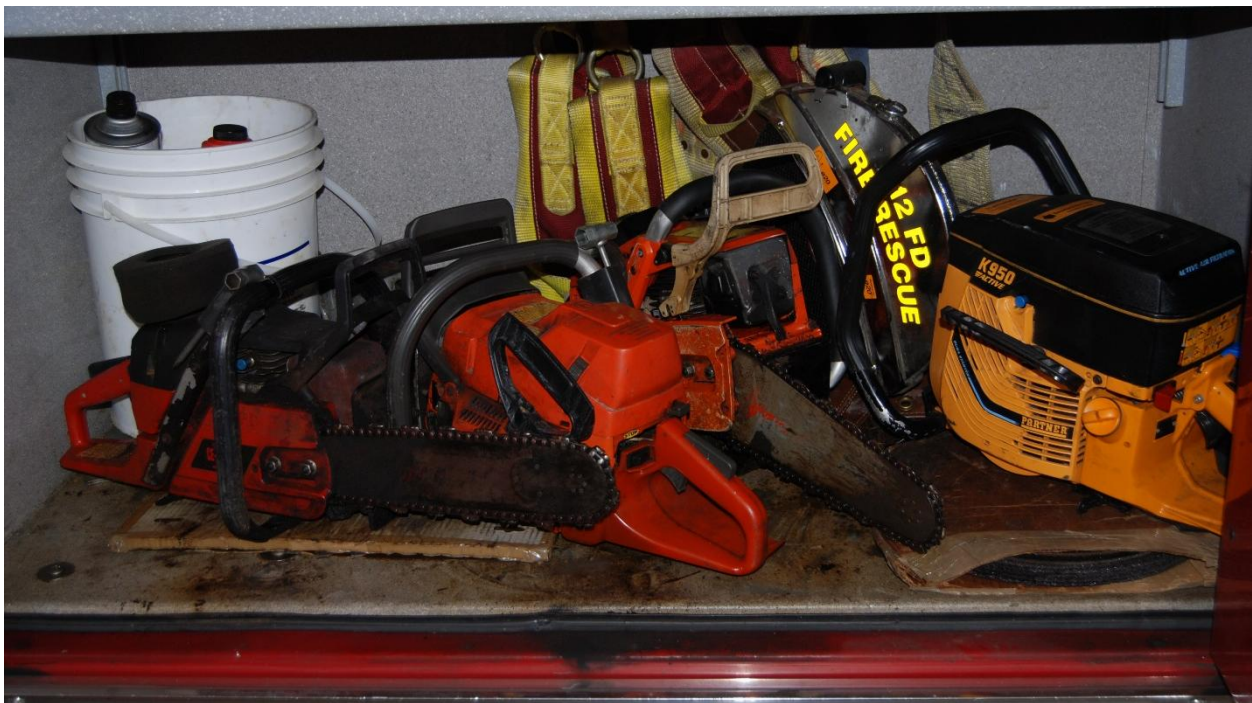
**Image 5.28 Gas powered saw equipment on Tower 1**

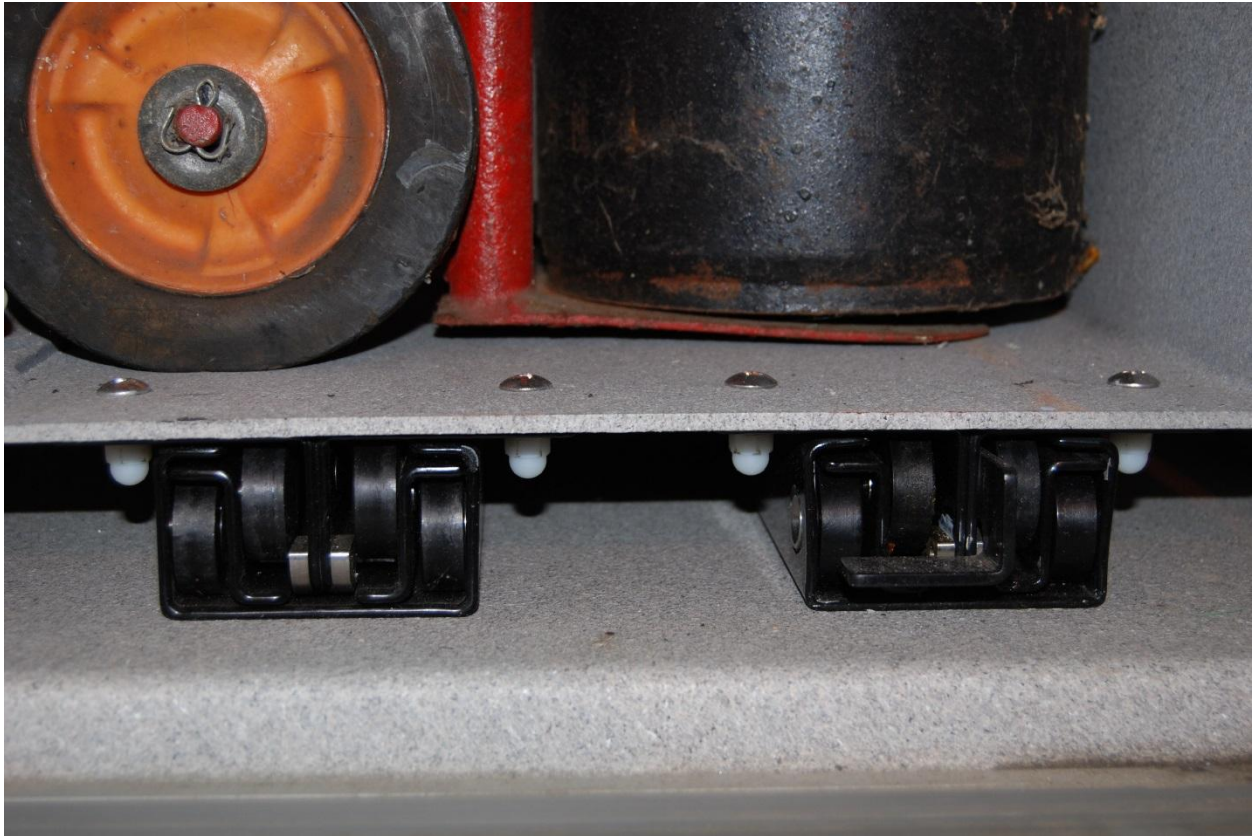
**Image 5.31 Rescue 1 Slide tray hardware floor mounts**

- 1. Floor mounted slide trays should be isolated from the stainless steel body with Nylatron or poly material to prevent corrosion due to dissimilar materials in this area.*
- 2. The chassis air reservoirs should be provided with drain valves and stainless steel cables extended to the side of the body to permit personnel to drain the air system on a regular basis without having to climb under the apparatus.*
- 3. The chassis frame rails, radiator and components should be periodically steam cleaned to remove surface rust and corrosion from this area. There is a minor buildup of rust and corrosion on the body sub-frame.*

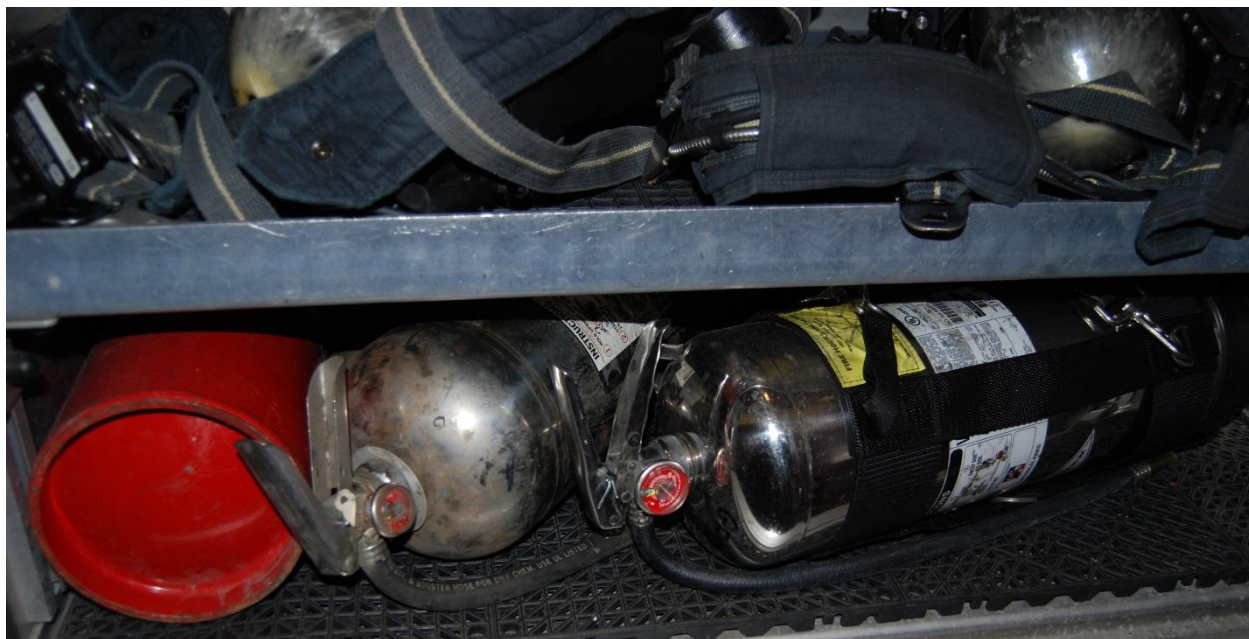
**Image 5.34 Loose fire extinguishers in right body compartment on Truck 6**

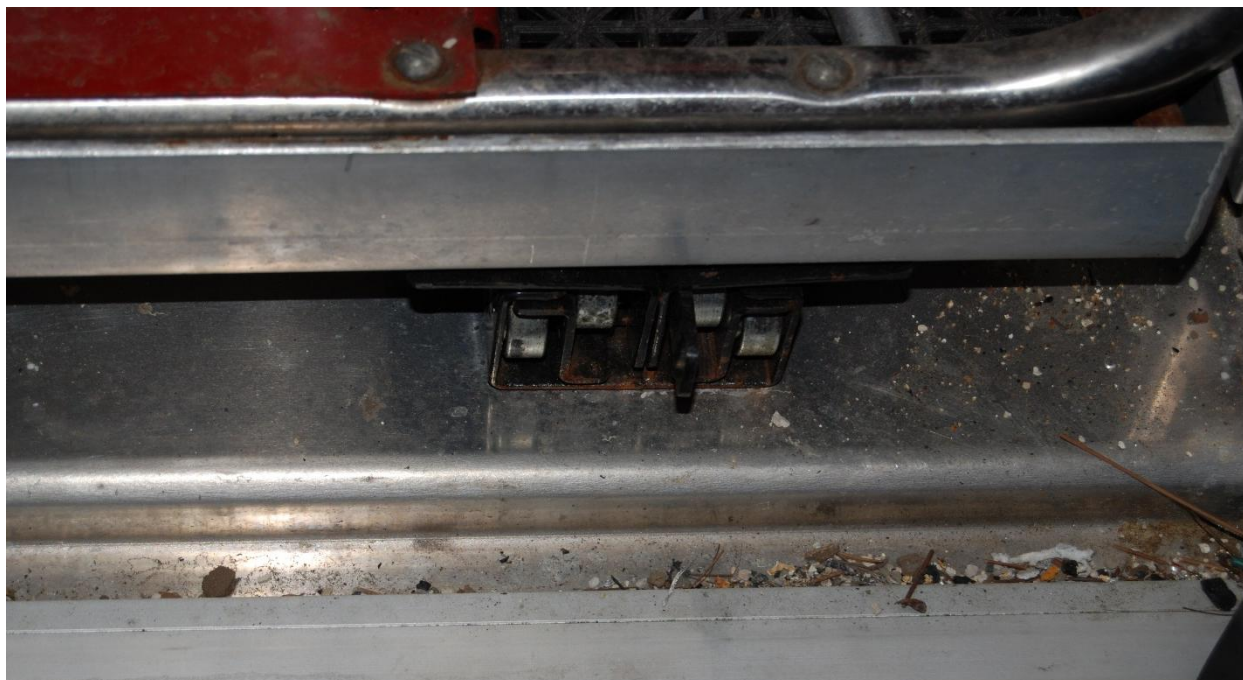
**Image 5.35 Minor rust on steel slide tray and debris at right front compartment on Truck 6**

- 3. The chassis frame rails, radiator and components should be periodically steam cleaned to remove surface rust and corrosion from this area.*
- 4. All interior compartments and floors should be cleaned of dirt and debris. The door gasket rubber on all of the side and rear body roll up doors should be replaced to reduce the infiltration of dirt and road debris into body compartments.*

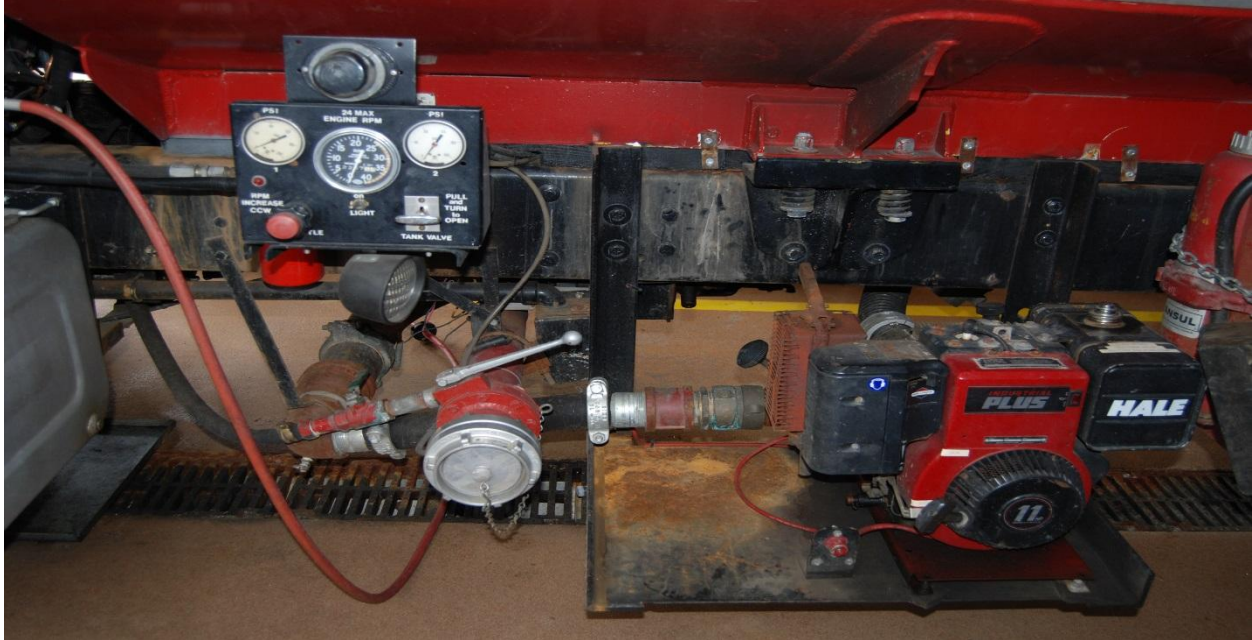
**Image 5.37 Portable pump mounting and controls on Tanker 1**

*Due to the age, condition and safety issues with Tanker 1, Emergency Vehicle Response recommends that this unit be taken out of service immediately, as this information was discussed with Assistant Chief Steve Charest upon conclusion of the field inspection work in the Town.*

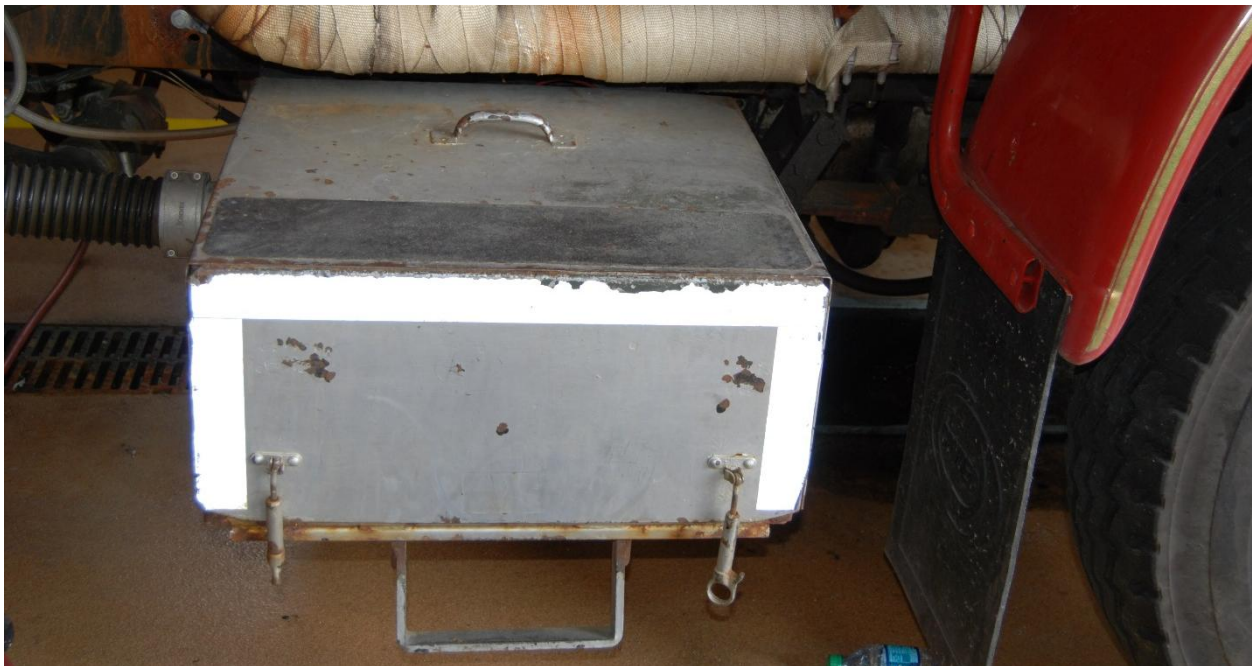
**Image 5.38 Right side step access on Tanker 1**

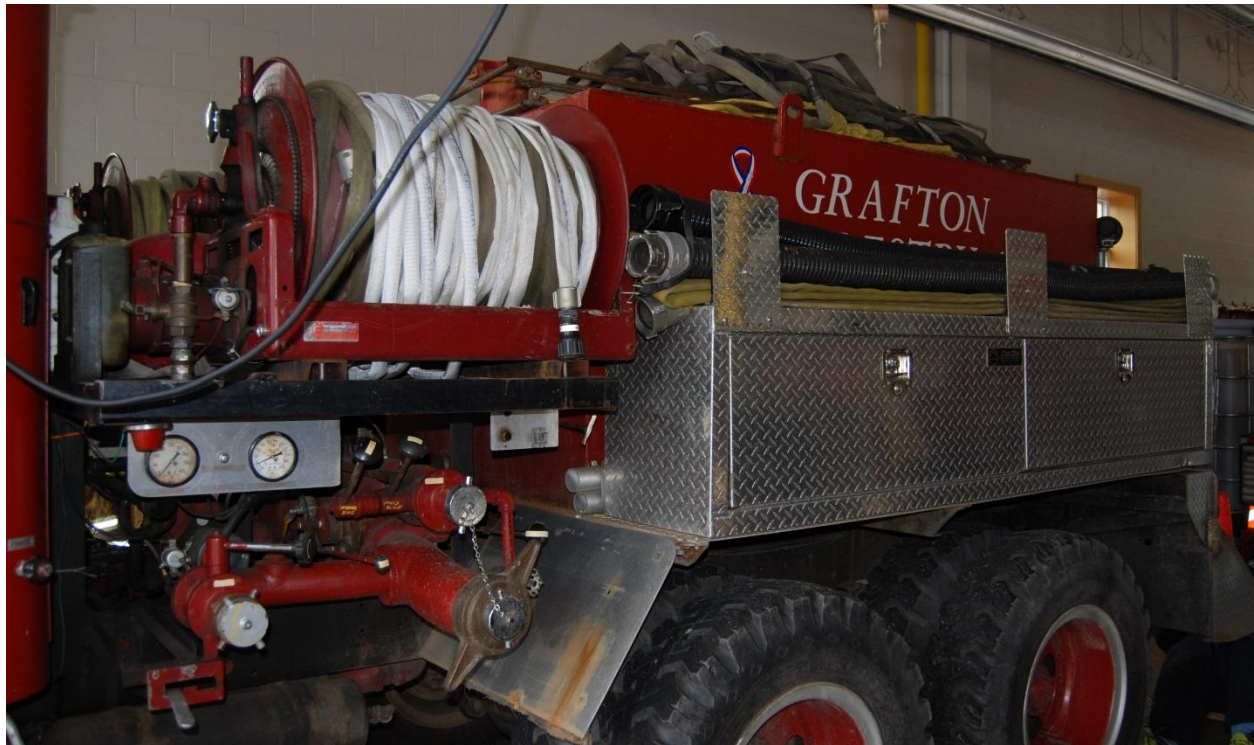
Image 5.40 Body and water tank on Forestry One

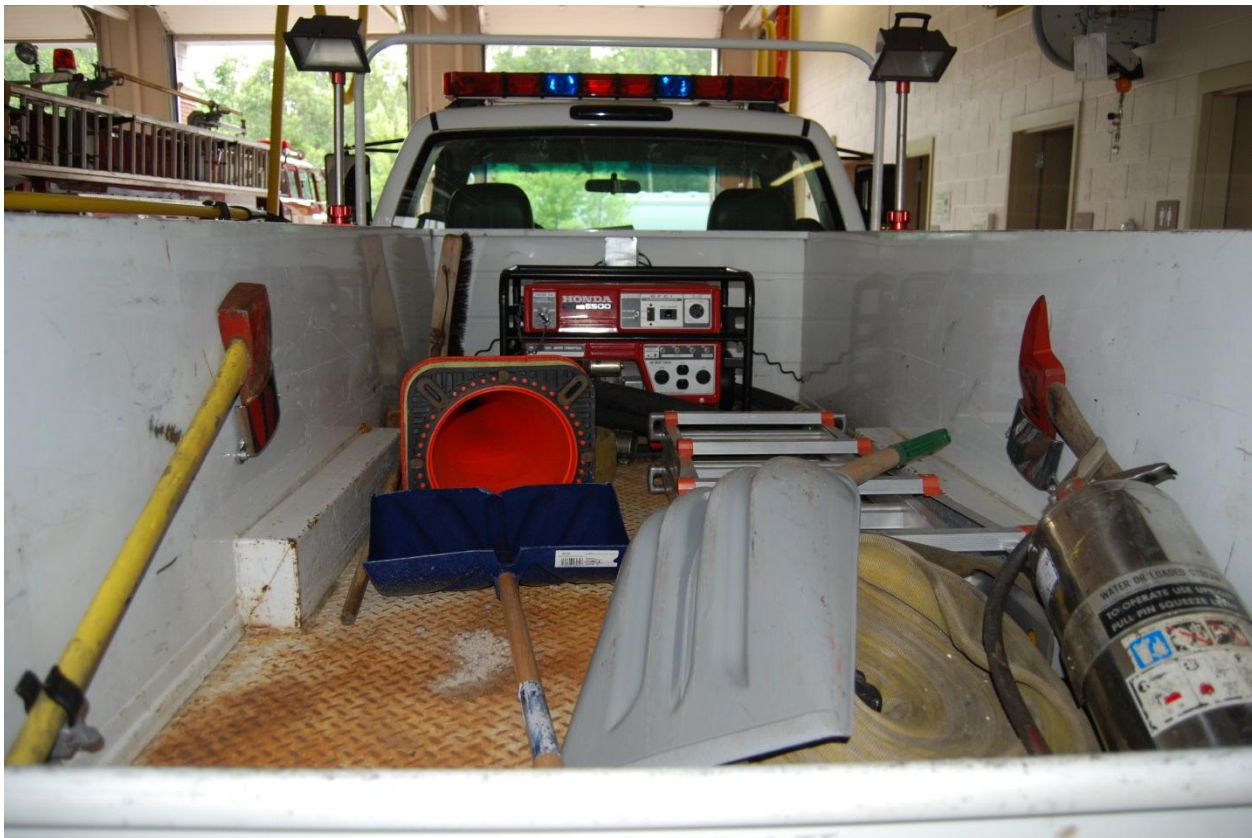
**Image 5.45 Equipment storage in rear body of M-2**
